ICH- LIEBE -FISCH | I LOVE FISH PROJECT

POND INSPECTION REPORT

FEBRUARY, 2018

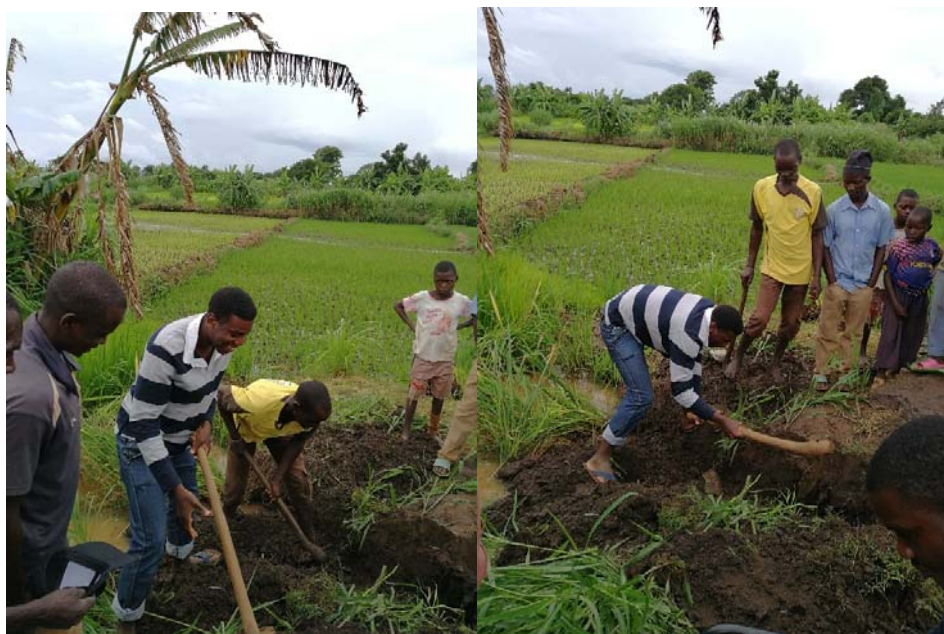
Figure 1: Teaching farmers how to open their ponds for draining

The farmers collaboratively drained the selected ponds and desilted them to remove all the mud and wild fish. This work involved three representatives from the respective clubs. The other three representatives were with the horticultural officer on the second pond site where they were practically learning how to identify crops suitable for their different soils they have, where and how to construct grow beds for fish vegetable integration system. The farmers were also taught how to maximize the utilization of pond mud by incorporating them into the vegetable grow beds and pond dikes.

Similar pond preparation trainings were conducted in Mchinji and Nkhotakota. However, both the farmers faced some challenges in the exercise. In Nkhotakota, the major challenge was that most of their ponds have no outlets as such they had to dig up the dikes to allow water to drain through. Additionally, the gradient inside the ponds is slightly at a lower side than the outside as such the water drains slowly and canals have to be dug deep to prevent backflow into the ponds.

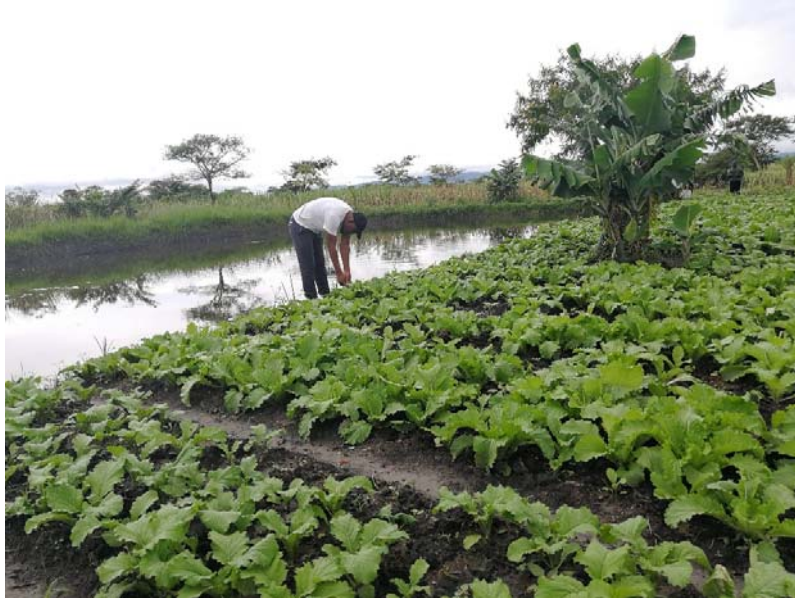
Figure 2: farmers in Mchinji (Tikondane Fish Club) sustained IAA systems during rainy season

Tikondane Fish Club already prepared their ponds and all the ponds are not stocked. Ntawa Fish and Chikondi club started preparing their ponds the day the inspection team visited them. Ntawa has one pond stocked by Local Development Fund (LDF) and all the Chikondi Fish Club ponds

are non-stocked. The horticulturist recommended the following vegetables; pumpkin leaves, Amaranths and local rape based on the soil type in the district.
